**Flood Control Project Maintenance
Levee Inspections**

Maintenance Issue Types Only, Levee Inspection Report By Mile - Spring 2019

Sutter Maintenance Yard Nelson Bend

Waterway	Bank	Unit Miles	Inspection Start/End	Inspector
Unit No. 01 Feather River West Levee - Nelson Bend		0.50	04/24/2019 04/24/2019	Sterling York

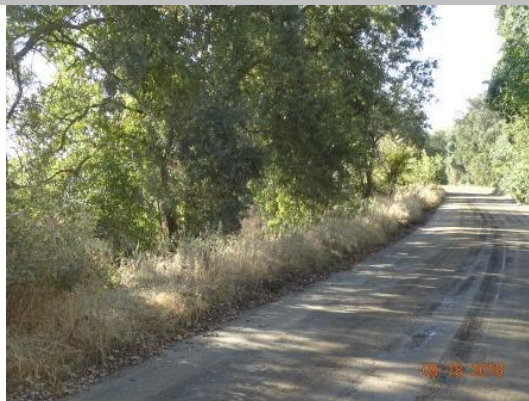
Photo 1 of 1 : SP_2019_ST0006_471_1_20190305_00001.jpg

LM Start	0.13	Rating **	U	Issue No.	1
LM End	0.50	Issue Type +	Ma	Location *	WS
Category	Earthen Levee			GPS Latitude/Longitude	
				Start	End
Item	Trim / Thin Trees			38.885396 °	38.880295 °
				-121.615595 °	-121.614147 °
DWR ID	DWR_ST0006_01_f_2017_1				
Comment Code					
T3 : Trim and thin trees to allow visibility of the ground and room to flood fight.					
Inspector Comment					
Trim up the trees to 5 feet above the ground for access and visibility, Spring 2019.

View looking downstream waterside of the over growth of trees.

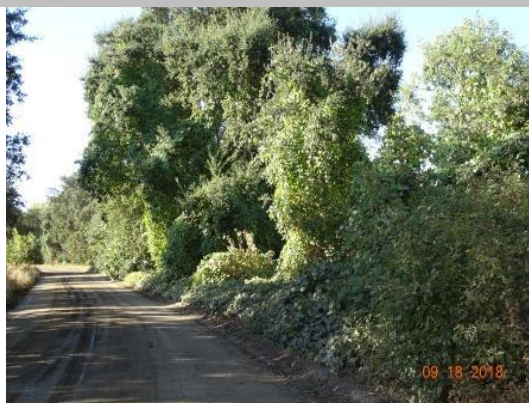
Photo 1 of 1 : SP_2019_ST0006_471_3_20190305_00005.jpg

LM Start	0.13	Rating **	U	Issue No.	3
LM End	0.50	Issue Type +	Ma	Location *	LS
Category	Earthen Levee			GPS Latitude/Longitude	
				Start	End
Item	Trim / Thin Trees			38.885396 °	38.880295 °
				-121.615595 °	-121.614147 °
DWR ID	DWR_ST0006_01_f_2017_3				
Comment Code					
T3 : Trim and thin trees to allow visibility of the ground and room to flood fight.					
Inspector Comment					
Trim up the trees to 5 feet above the ground for access and visibility, Spring 2019.

View looking downstream landside of the over growth of trees.
